# Axle Bearing NIR Investigation 2016

## Report v1

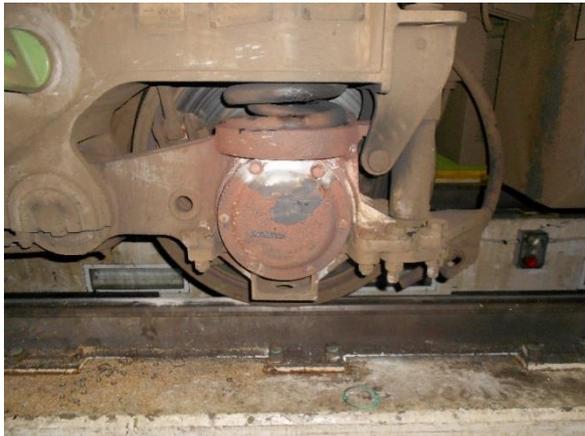
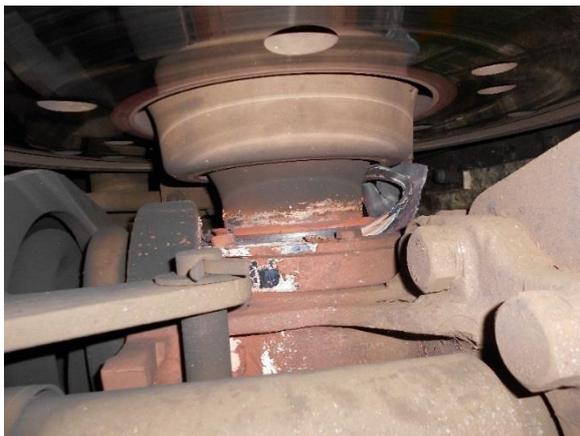
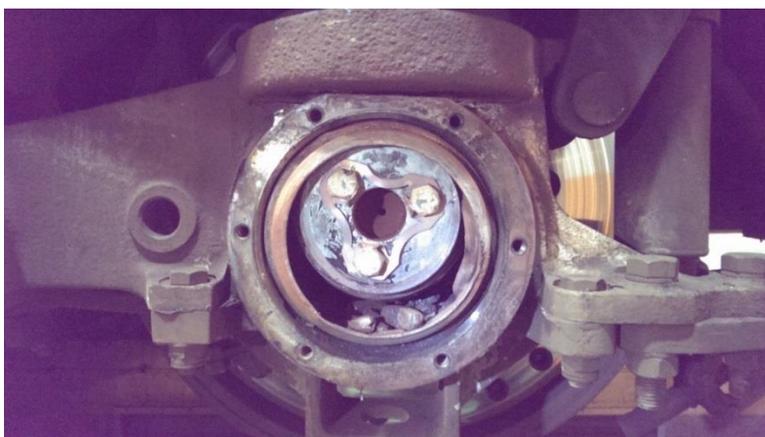
### 458026 catastrophic Axle Bearing Failure - Defect date 17 February 2015

The immediate cause of the bearing failure is unknown as the failure has destroyed all evidence of any prior defects. Extrapolation from the condition of the other bearings on the vehicle suggest that the underlying cause is electrical damage, possibly occurring because of defective earthing braids.

**No** human factor error has been assigned to this, nor human error.

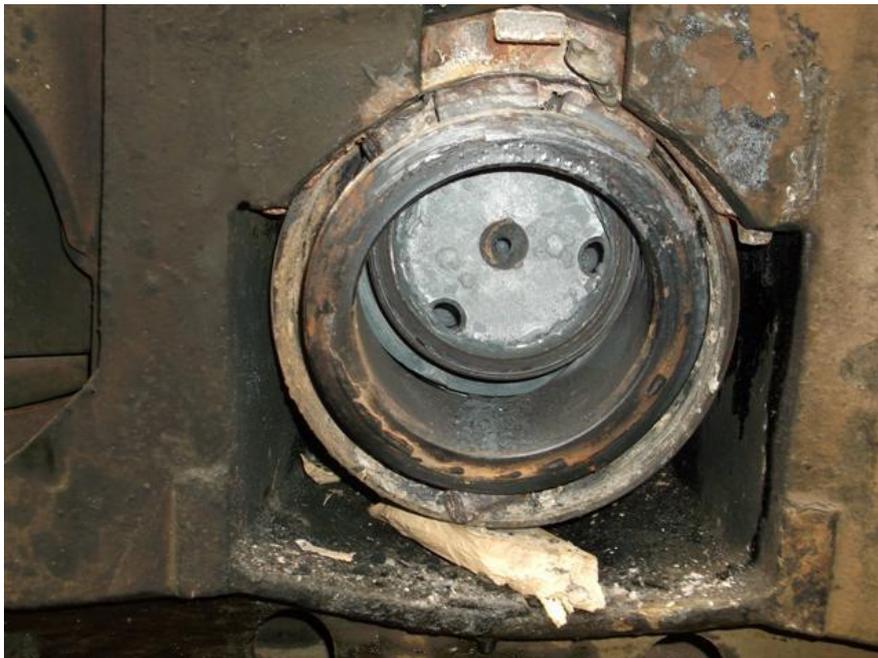
Catastrophic Axle Bearing Failure – PCA 51T Cement Tank Wagon - Defect date 7 September 2015

The immediate cause of this defect was that a wheelset was delivered with no axle end caps fitted to either end. All documentation had been correctly signed off. This is a typical human error failure categorised as memory lapse.

An underlying cause of this was the workshop practice, which had this action carried out to a number of wheelsets located on floor level track, normally working along one side and then the other. Wabtec, Scotland has introduced a fixture which locates an individual wheelset at a sensible height and which is just used for all axle end processes. It has also amended the route cards, to improve the clarity and recording of this task. A human factors issue could be **supervision and management**.

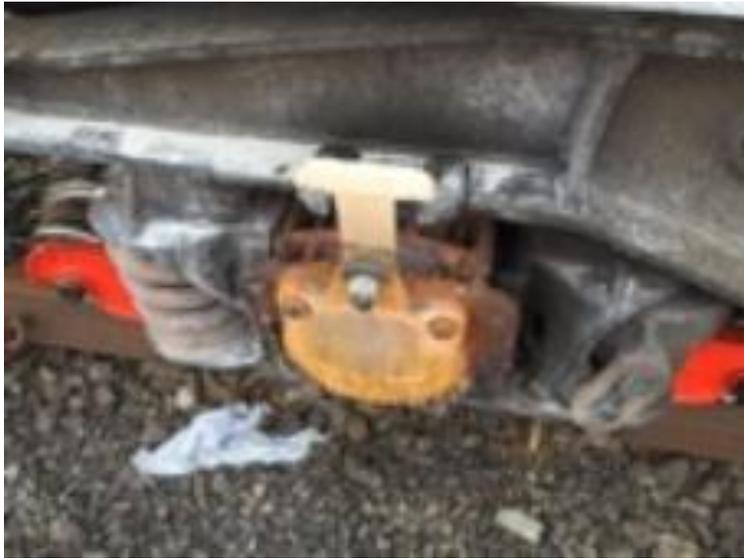
Catastrophic Axle Bearing Failure – JGA Wagon - Defect date 27 August 2015

The immediate cause of this incident was the failure of a bearing. The bearing had been overhauled in May 2011 and the wheelset turned in 2014.

The bearing was examined by a specialist but no underlying cause of failure could be found.

**No** human factors issues have been identified.
