# Axle Bearing NIR Investigation 2016

## Report v1

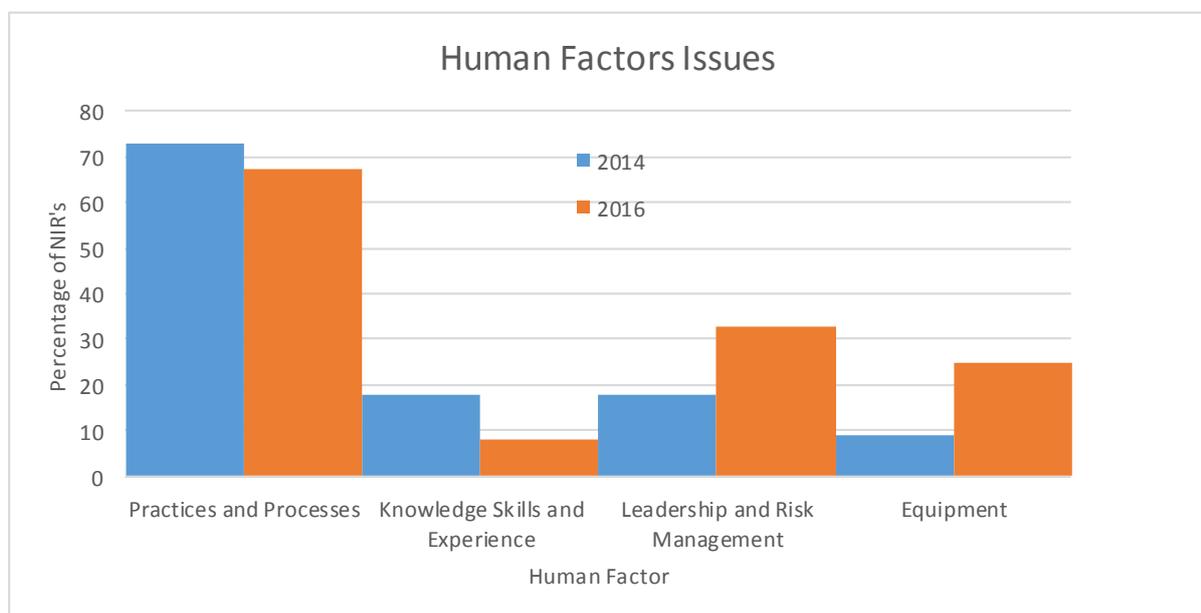
**Fig 1: Comparison of Human Factors**

The chart in Fig 1, compares the percentages of the 2014 findings with those in this report. There has been a slight change in the distribution, with a small reduction in the frequency of knowledge and skills. However, this is offset by an increase in leadership and risk management and also equipment. The equipment issue is all associated with procurement and effective control of suppliers, so there needs to be greater emphasis on these issues. The drafting of RIS-2750-RST should help to address the issues identified in this report.

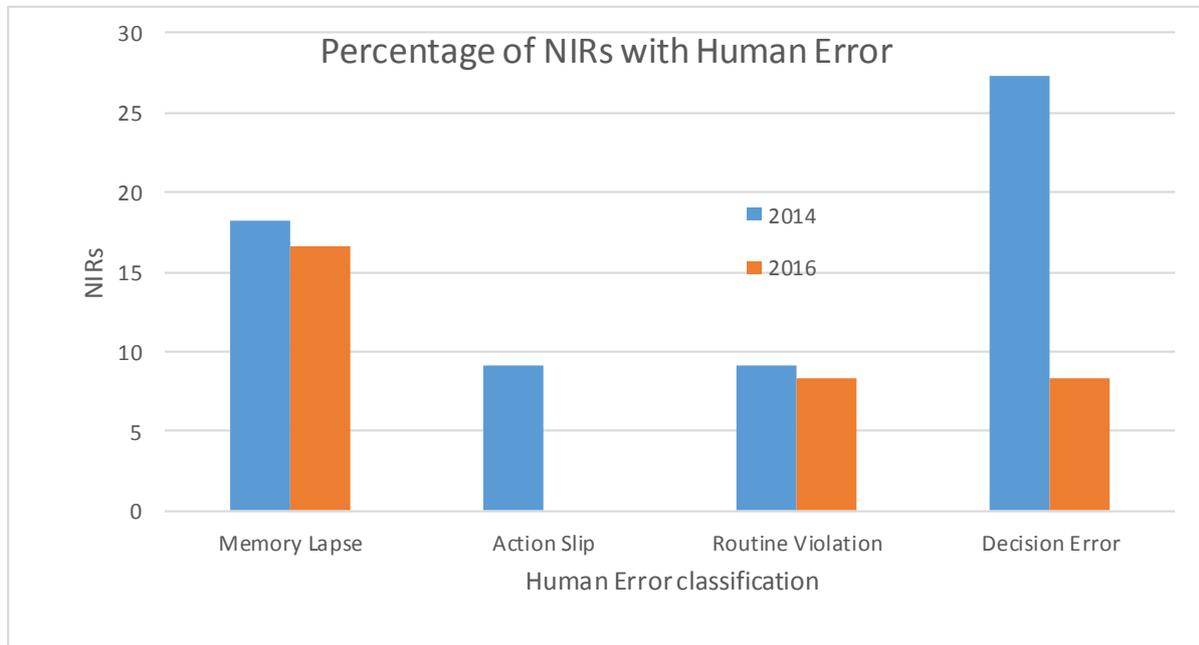
**Fig 2: Comparison of Human Error Classifications**

The chart Fig 2, shows the percentage of each type of human error.

The figures show a small reduction in human error, from seven in the 2014 report to four in this report. However, where it has not been possible to identify the error specifically, no category has been assigned. The only significant change is a reduction in decision errors.
